## **BPI Building and Pest Inspections Wollongong and Southern Highlands**

5 Windle Street,  
Lake Illawarra, NSW 2528

# BPI - INSPECTION REPORT

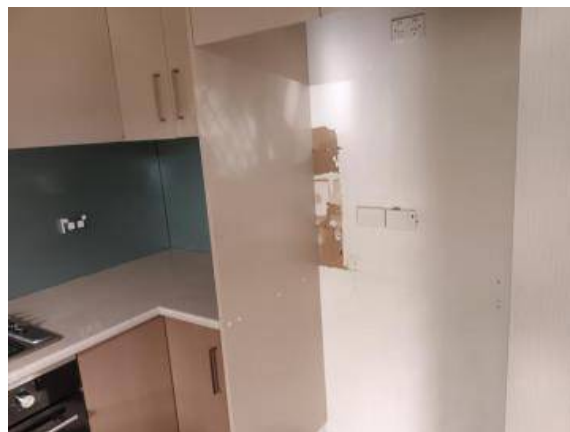
Some minor damage to wall sheeting requires touching up / repair / repainting.

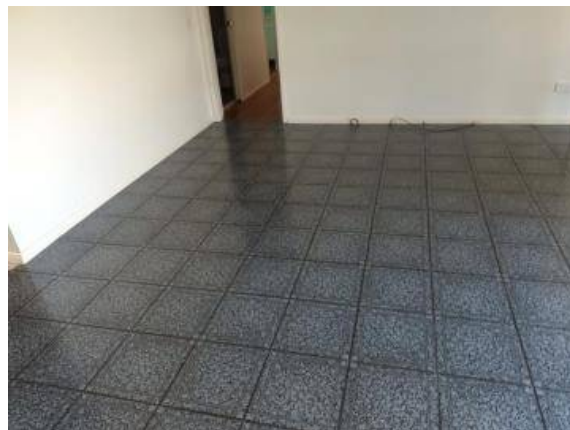
There is evidence of undulations to some flooring consistent with a house of its age & construction.

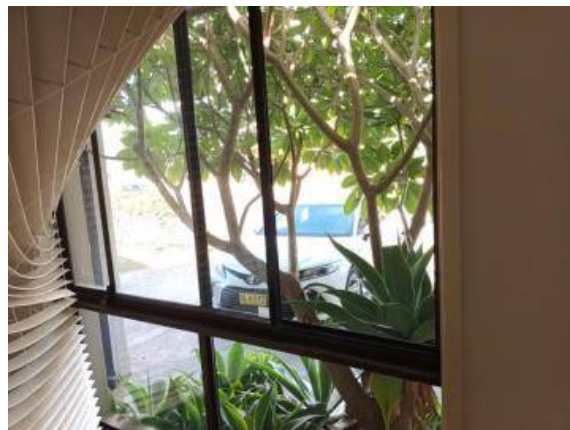
Various window slider rollers show signs of wear or are worn and require lubrication / maintenance.

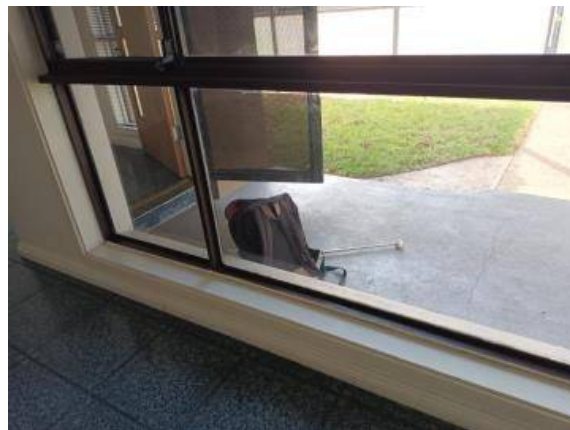
Various window glazing seals have hardened / perished / shrunk and require repair / replacement.

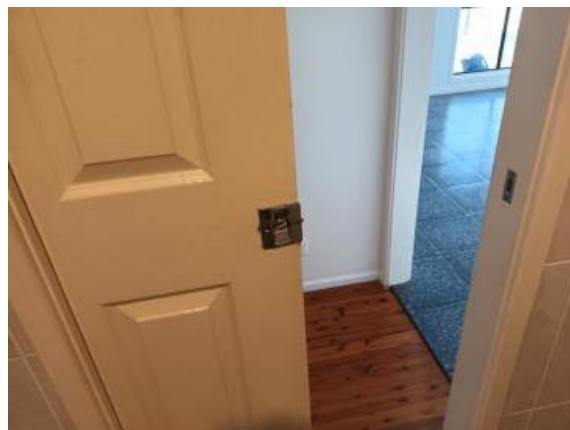
Some door hardware requires adjustment.

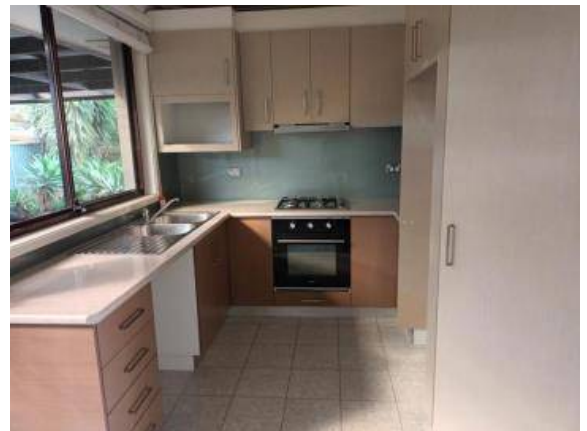
**Damage**  
The Kitchen cabinetry / bench tops / laminate show evidence of general wear & scratches.

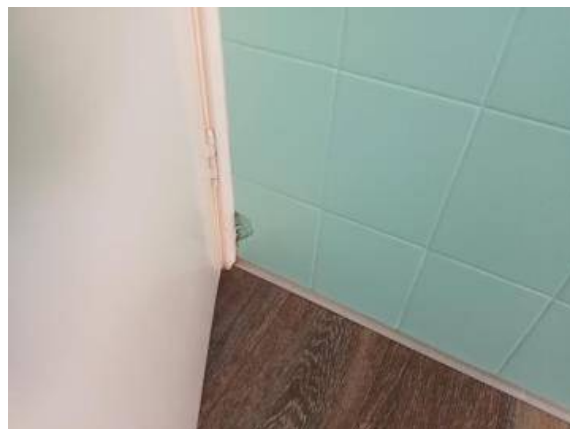
Drummy floor tiles present to various areas. Floor tiles become drummy due to the loss of adhesion to the underside of the tiles and may become loose or cracked. I recommend that a qualified tiler be engaged for further inspection / advice.

Cracks / damage to some wall tiles to bathroom.

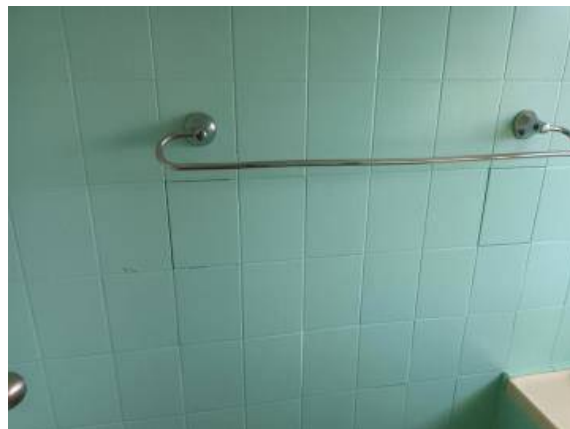
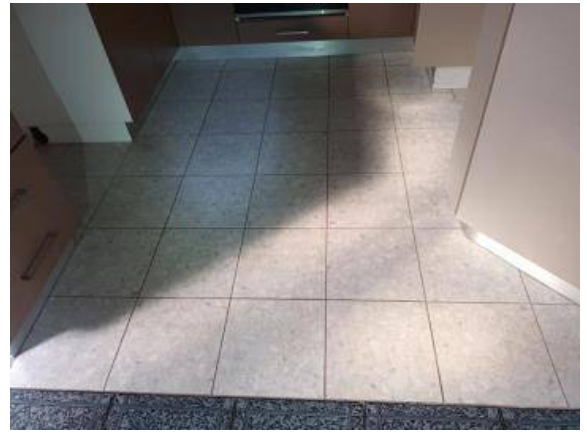
Some floor and wall tiles require regrouting and resealing.

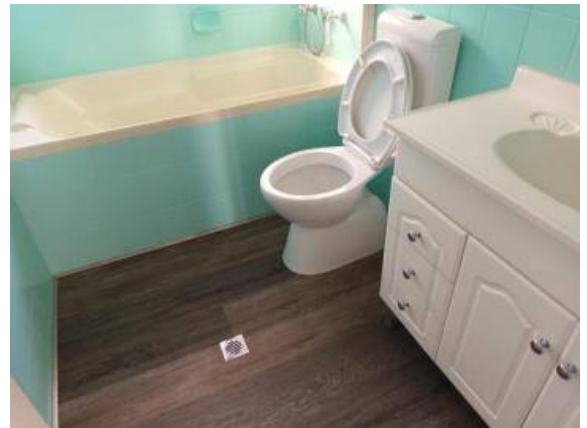
Toilet pan base is loose and requires refixing in place.

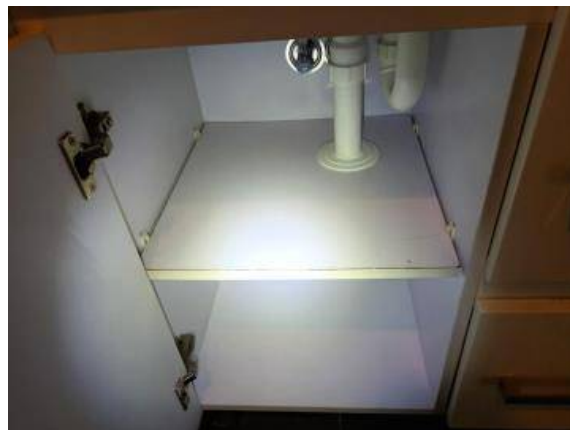
Signs of past water damage to Bathroom vanity cabinet.

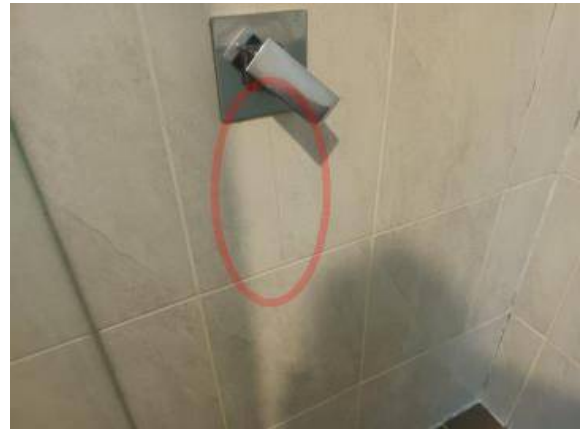
Crack to shower wall tile.

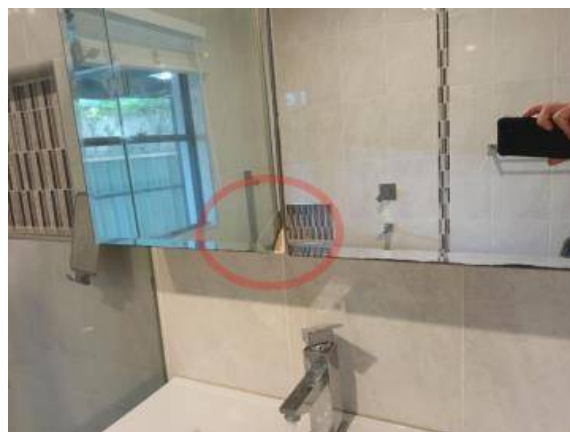
Cracks to mirror to shaving cabinet.

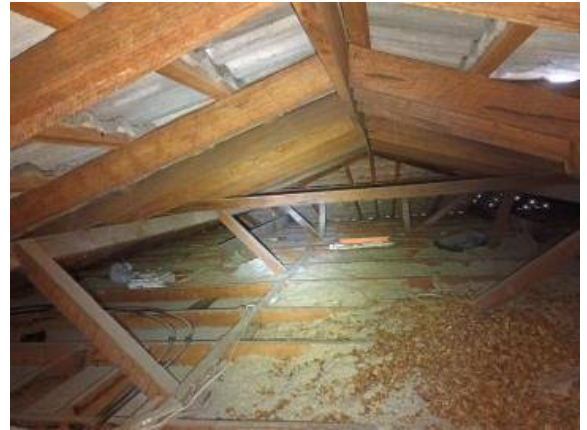
Older roof frames do not comply with the current NCC standard wind ratings. The roof framing is in satisfactory / typical condition for the age / construction date.

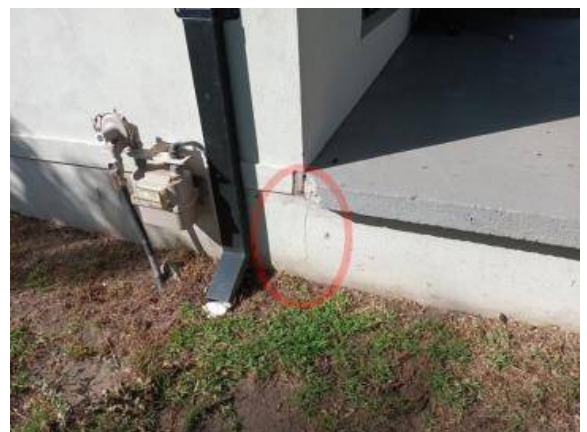
Hairline cracks to render. *These types of cracks are normal / common and are generally due to minor settlement &/or material shrinkage consistent with the age of the building. I recommend all evident cracks be adequately sealed with a suitable sealant to aid in preventing moisture ingress.*

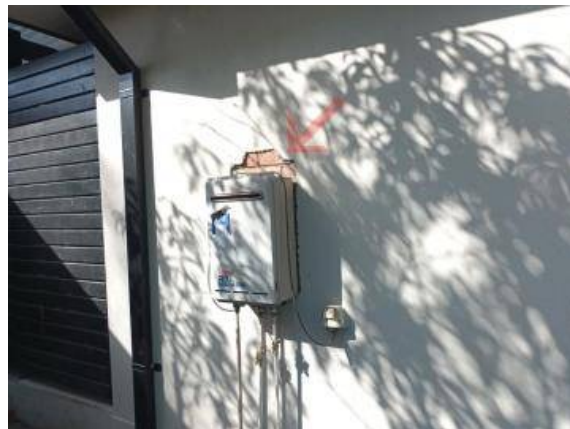
Render around hot water system is unfinished and requires repair.

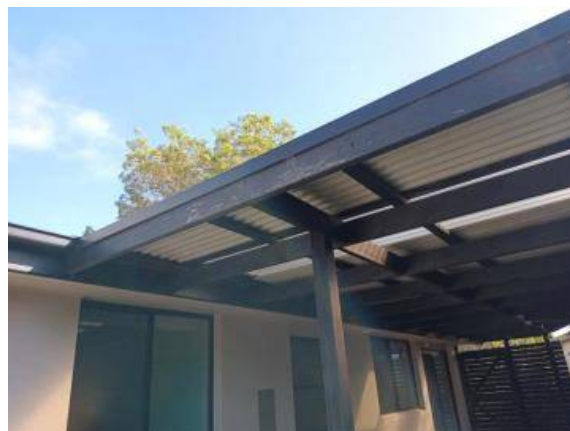
Some external timberwork requires touching up / repainting.

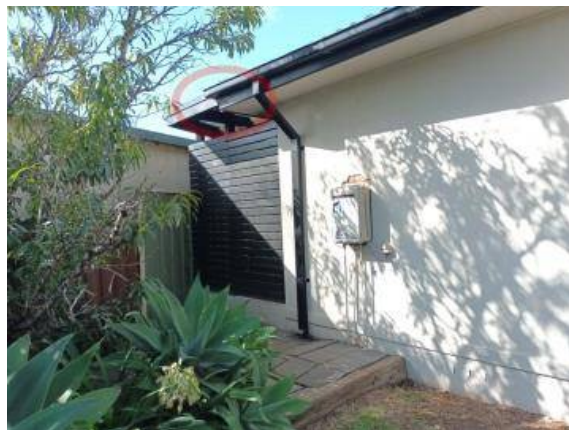
Some fascia timbers show signs of minor weather damage and require repair / repainting.

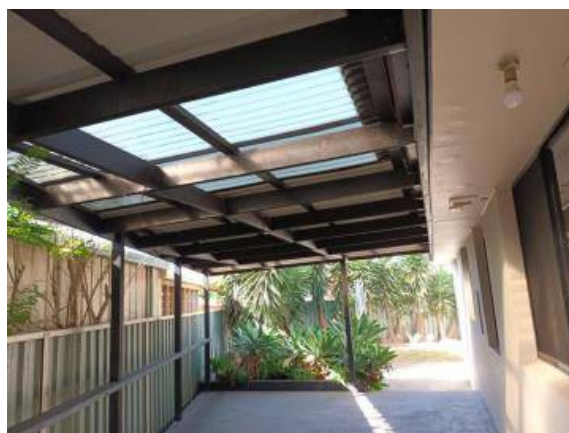
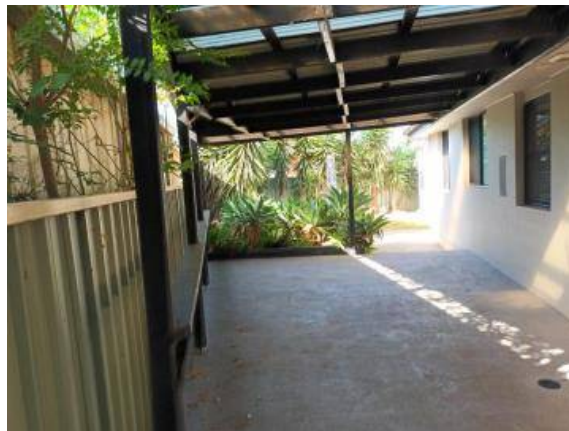
Some surface cracks present to the Patio slab(s). These types of cracks are common / normal and due to minor settlement / material shrinkage.

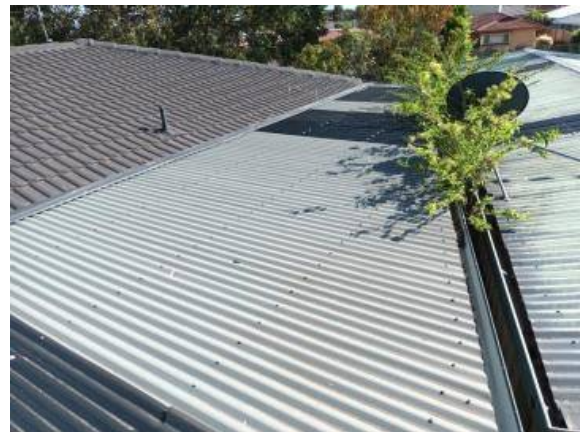
Condition:  
The Patio roof pitch is below the manufacturers recommendation of a minimum 5 degrees pitch for corrugated roof sheeting. This may cause the roof sheeting to leak / rust / deteriorate. It is recommended Trimdek / Cliplock type roof sheeting be installed for roof pitches less than 5 degrees. I recommend that a qualified roofer be engaged for further investigation / advice.

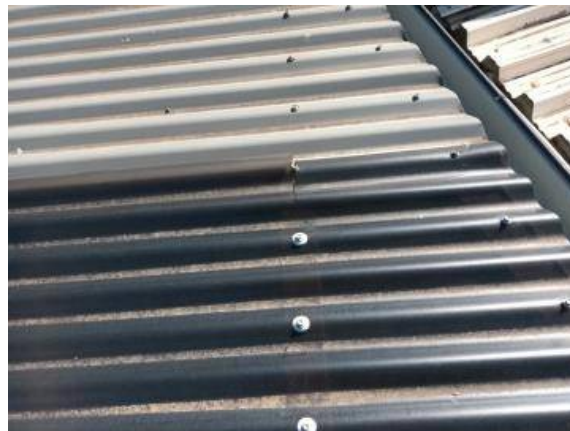
Damaged polyurethane sheeting requires repair.

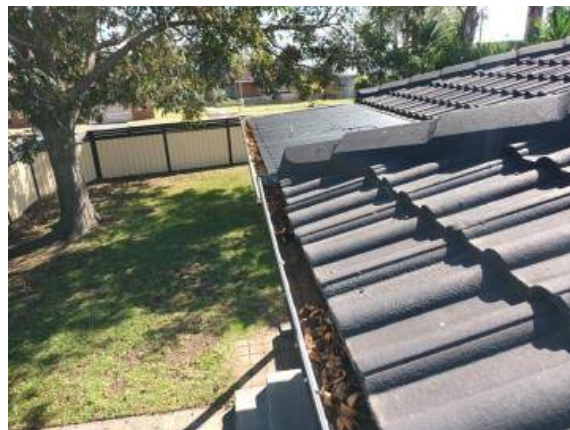
Some sections of guttering are full of debris and require cleaning. Failure to do so may allow water to become blocked and back flow into the roof void causing water damage.

Extend downpipes to discharge storm water runoff away from the perimeter of the residence or have them connected to a stormwater dispersal system.

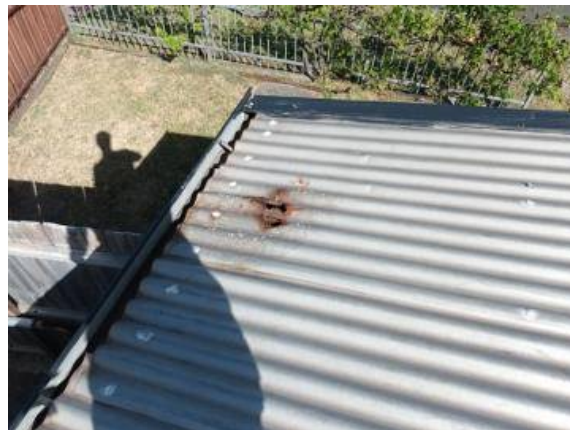
Some roof sheeting is rusted and require repair / replacement.

Evidence of past resealing to the roofing screws. I recommend a qualified roofer be engaged to replace the screws to prevent leaks.

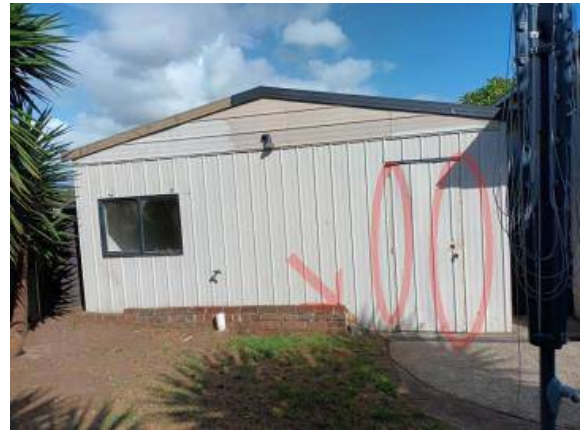
External cladding shows signs of rust and requires repair / repainting.

Roller door lock requires repair. I recommend that a qualified Garage door technician be engaged for further investigation / maintenance.

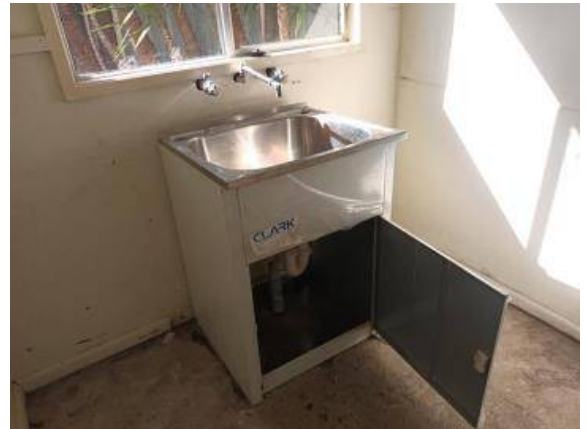
Laundry tub requires fixing to wall.

Waste pipe requires connecting / repair.

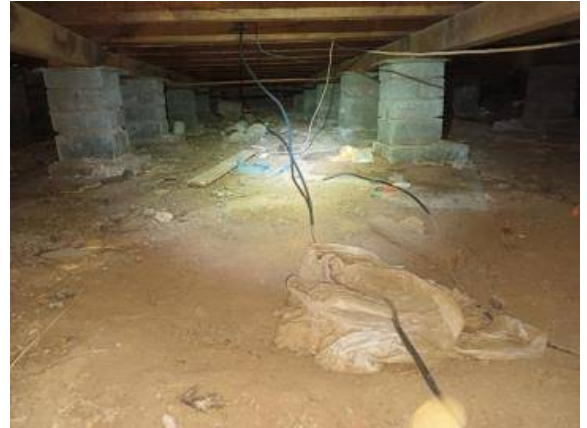
- We recommend that all untreated / loose timbers within the Subfloor area be removed or treated with termiticide as these predispose the property to termite attack and are a high attractive food source.

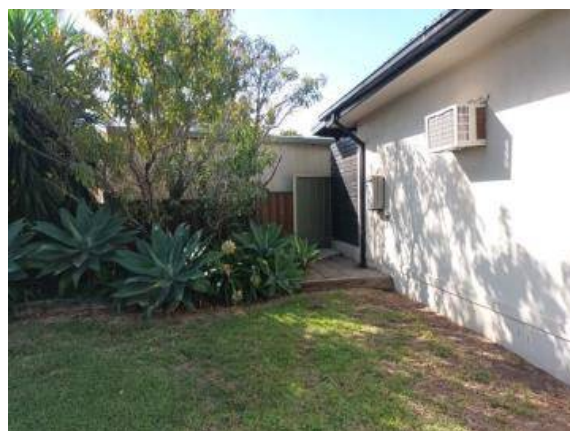
- Tree stumps should be removed or treated with termiticide as they provide an area for termites to establish a colony.

- Some perimeter physical termite barriers are abutted / covered by some external concrete slabs. I recommend you contact the Termite Physical Barrier installer / manufacturer for further inspection to investigate whether the Physical Barriers have been breached and if the warranty is still valid. If the barrier / warranty has been breached / compromised, you should install an additional chemical termite barrier system with a warranty.
