## **BPI Building and Pest Inspections Wollongong and Southern Highlands**

5 Windle Street,  
Lake Illawarra, NSW 2528

# BPI - INSPECTION REPORT

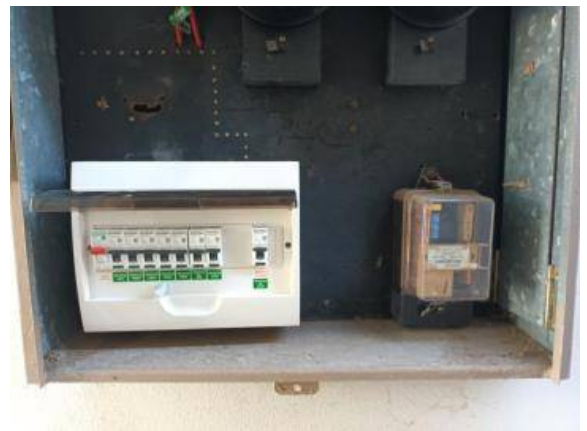
Whilst not an electrician, it appears that an electrical safety switch is present.

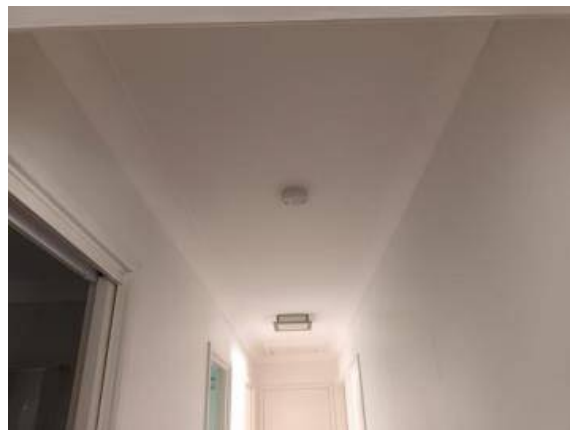
Present - Hall.

- Smoke alarms are noted but not tested, this is outside the scope of a standard building report & our expertise.
- A smoke alarm specialist should be consulted to test & advise on those installed or install new detectors / alarms if / where required.
- Any existing smoke alarms manufactured more than 10 years ago should be replaced with photoelectric smoke alarms which comply with Australian Standards (AS) 3786-2014.
- Battery operated smoke alarms should be checked routinely and the batteries changed frequently.
- From 1 January 2022, landlords must install interconnected photoelectric smoke alarms in residential rental properties in accordance with Australian Standards (AS) 3786-2014.

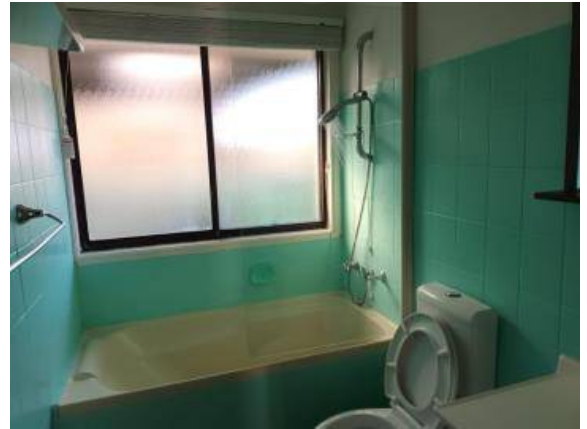
Crack to shower wall tile.

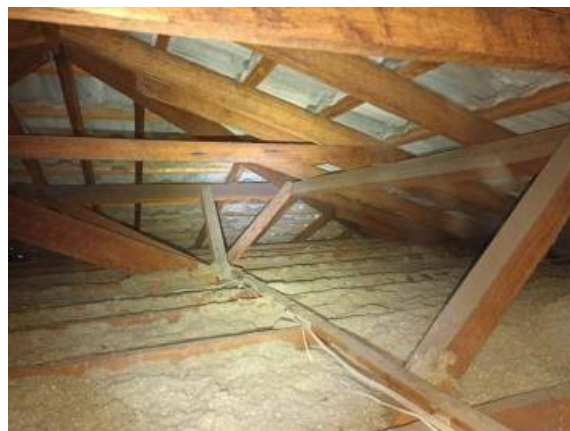
Stick - Hardwood.

Older roof frames do not comply with the current NCC standard wind ratings. The roof framing is in satisfactory / typical condition for the age / construction date.

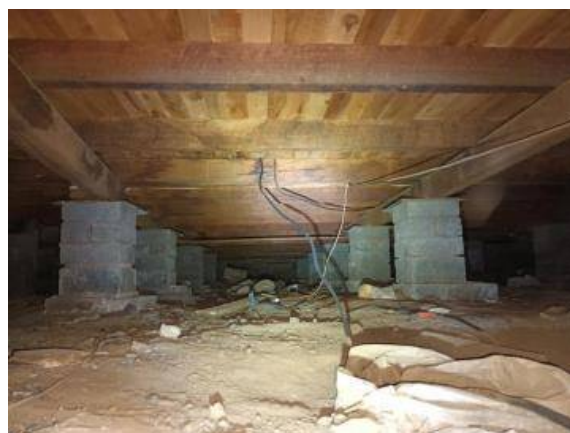
Older floor frames do not comply with current wind ratings. This subfloor / frame is in satisfactory / typical condition for the age / construction date.

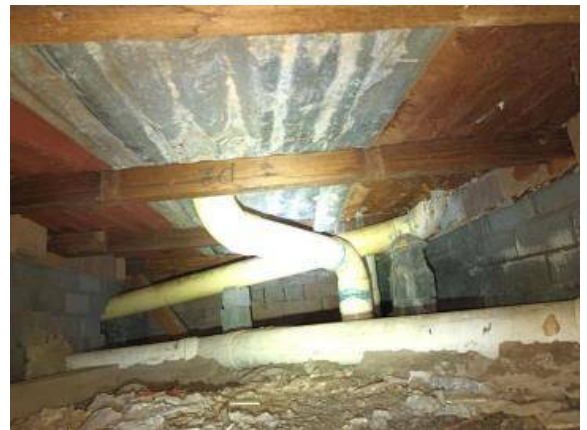
The underside of the suspended concrete slabs are lined with iron sheeting. No inspection of those concrete surfaces could be carried out.

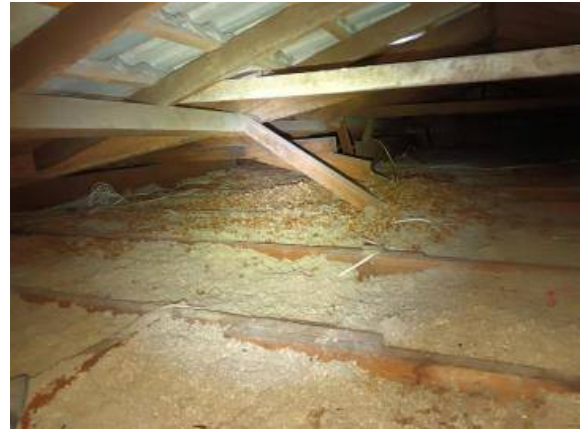
Insulation is present in the roof cavity. This restricted inspection to some roofing & ceiling members and wall top plates. Removal of insulation is not within the scope of a standard visual timber pest inspection report.

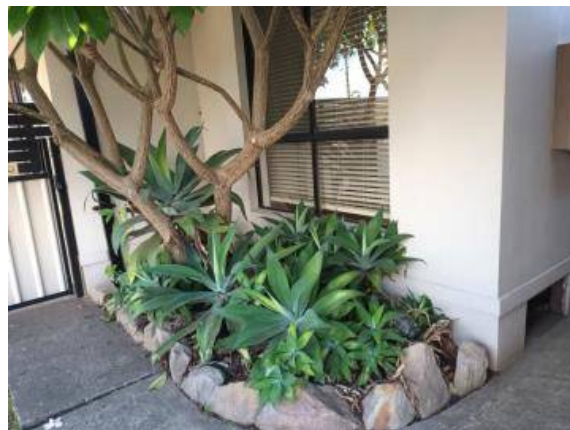
Inspection to areas and sections of the exterior was restricted due to the growth of foliage. Foliage should be removed as foliage may be concealing timber pest activity.

**Further inspection of these areas is strongly recommended once access has been obtained.**
